# UNDERWATER BRIDGE INSPECTION REPORT

STRUCTURE NO. 5884

NORTH FORK OF THE CROW RIVER

DISTRICT 8 - KANDIYOHI COUNTY

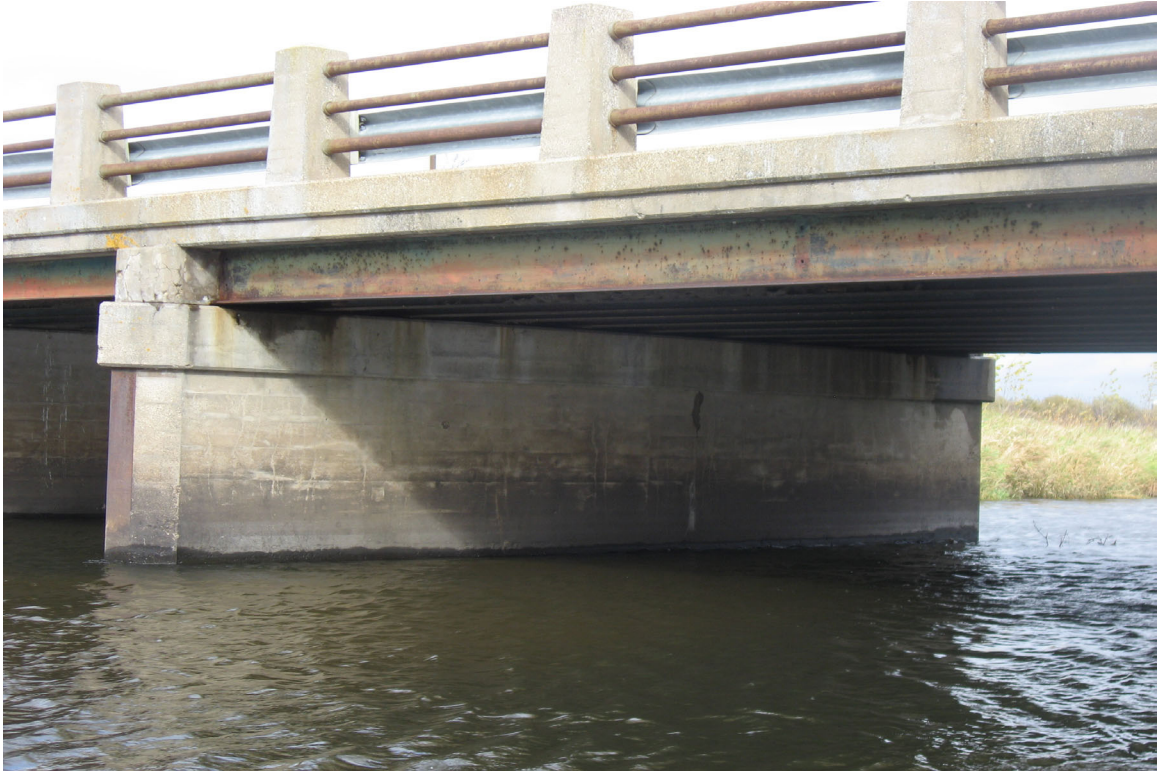
Photograph 1. View of Pier 1, Looking Northeast.

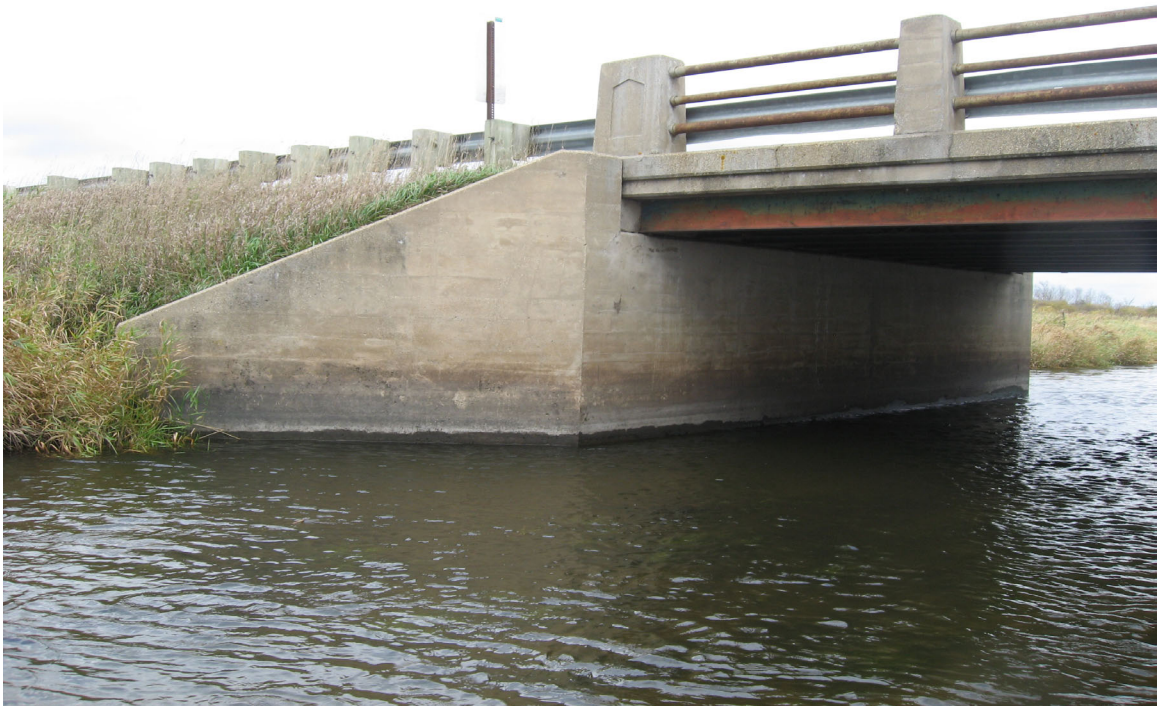
Photograph 2. View of the North Abutment, Looking Northeast.

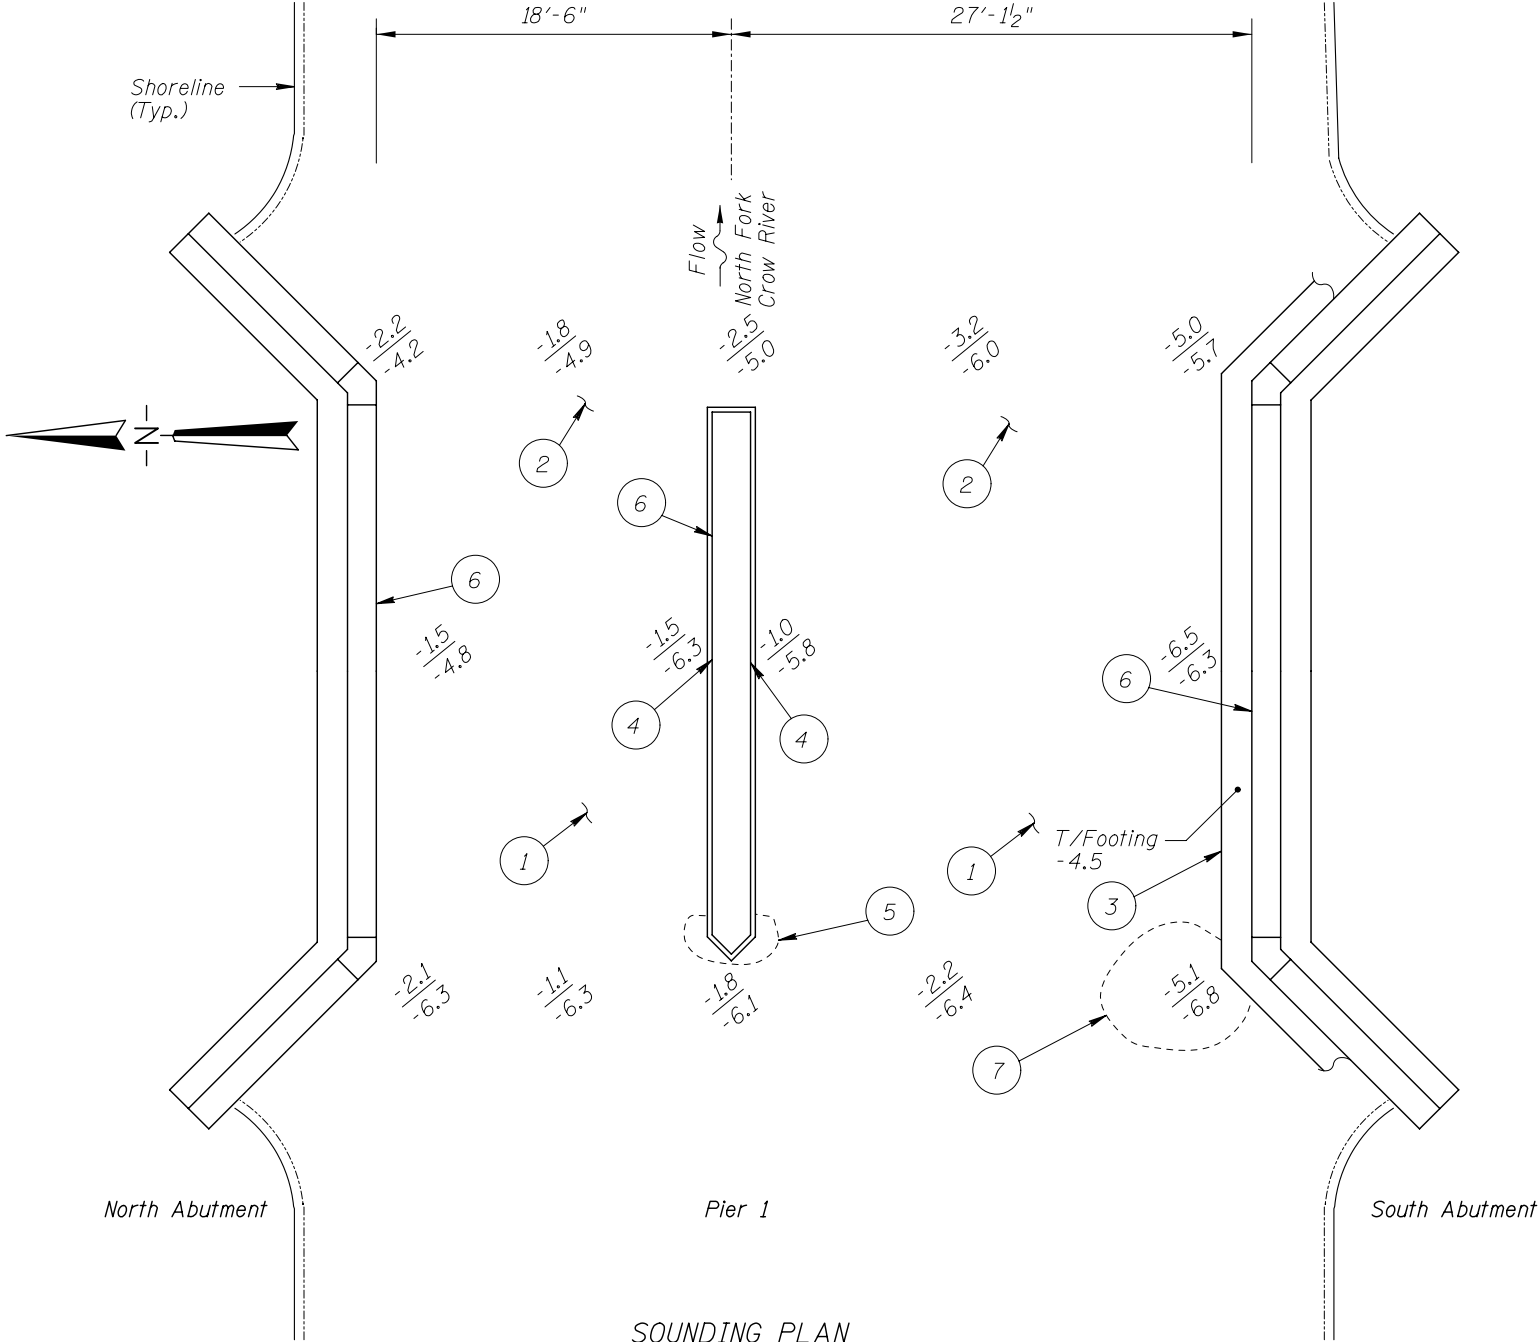
- INSPECTION NOTES:
1. The channel bottom consisted of silt with up to 1.5 feet of probe rod penetration.
  2. The channel bottom consisted of silty sand with 2- to 4-inch-diameter cobbles with 2 to 4 inches of probe rod penetration.
  3. The top of the footing was exposed along the entire breastwall and along half of each of the wingwalls, with up to 2 feet of vertical face exposure.
  4. Two vertical 1/32-1/16 inch wide cracks, which extended from the top of the pier cap to the channel bottom, were observed on both faces centered at the midpoint and 6 feet apart.
  5. A 3-foot-radius, 1.5-foot-deep scour pocket was observed at the downstream end of the pier.
  6. A band of minor scaling was observed at the waterline on all substructure units.
  7. A 6-foot-radius, 2.5-foot-deep scour pocket was observed at the upstream corner of South Abutment.

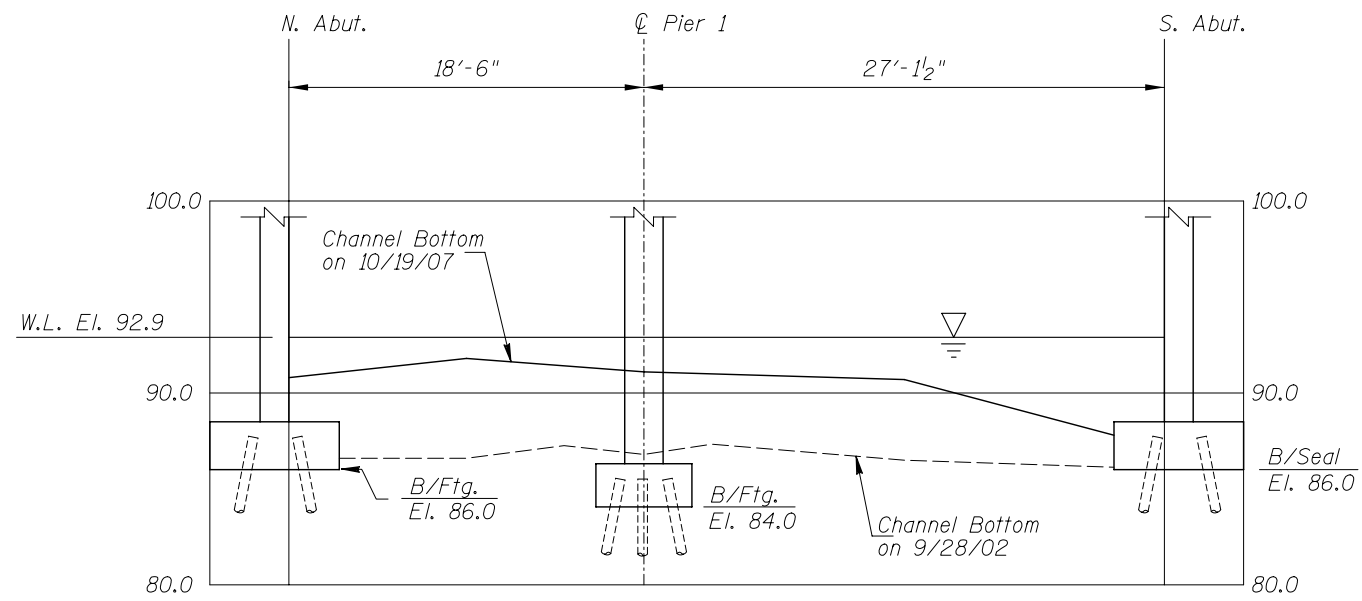
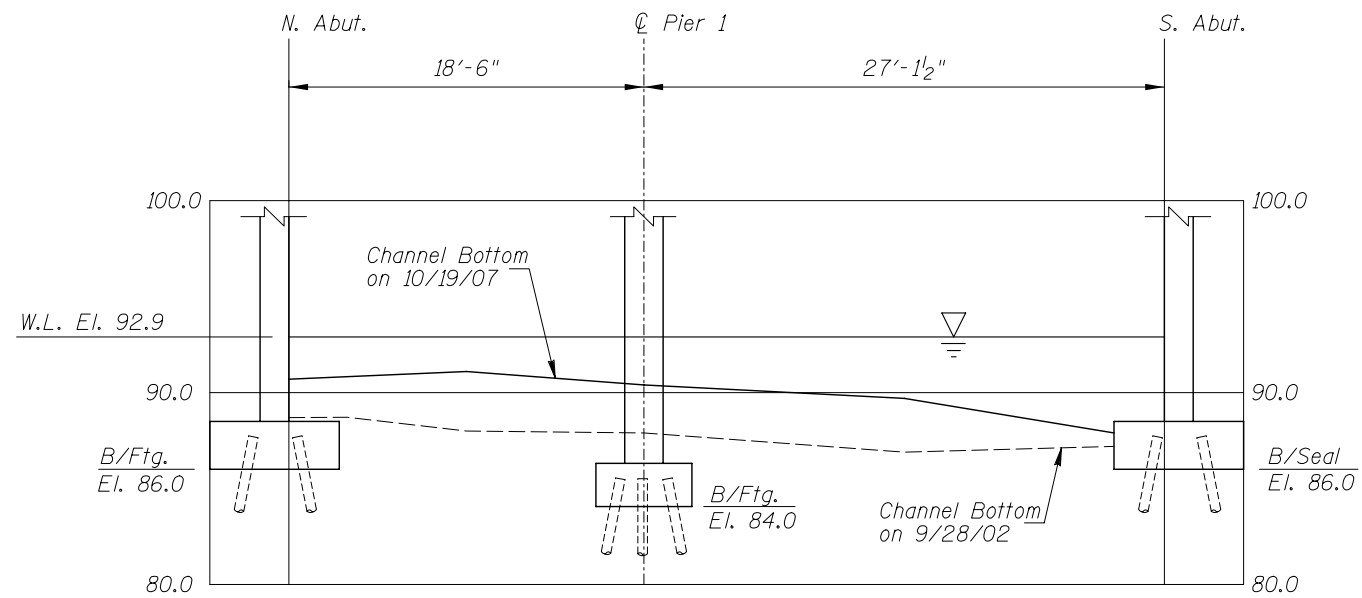
Date: OCT. 2007  
Scale: 1"=10'  
Figure No.: 2

UPSTREAM FASCIA PROFILE

DOWNSTREAM FASCIA PROFILE
